# **Pipeline Inspection, Design, and Failure Analysis**

White Paper | Berkeley Engineering And Research, Inc.

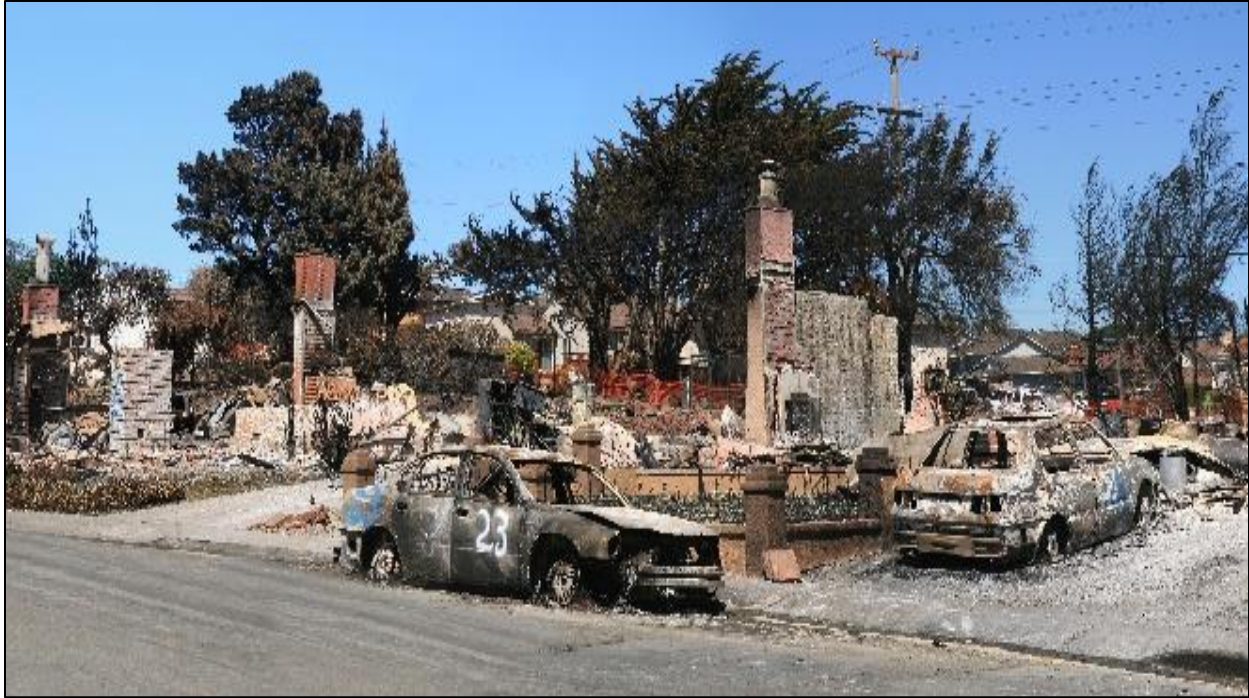
AFTERMATH OF THE SAN BRUNO PIPELINE EXPLOSION. BROCKEN INAGLORY, CC BY-SA 3.0

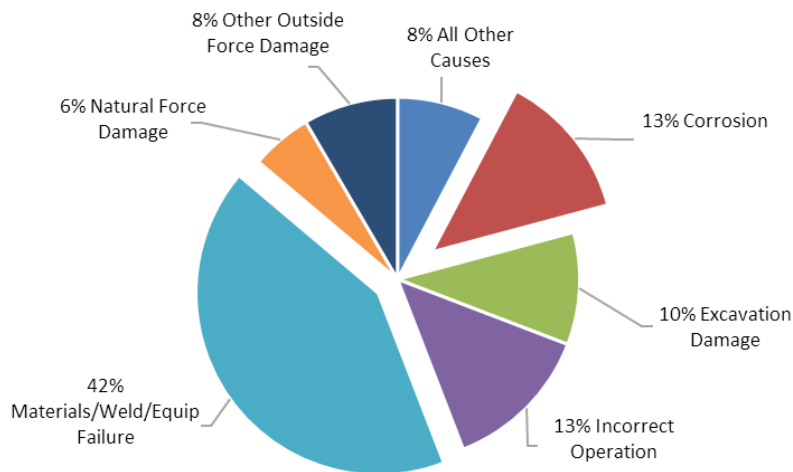
FIGURE 1 SOURCE: PHMSA.DOT.GOV (12/11/2019)

Material, weld, and equipment failures are the most common root cause of pipeline failures based on PHMSA data representing 42% of all cases reported, shown below. Corrosion and incorrect operation follow— each at 13%. BEAR has the capability to identify, differentiate and explain all of the various root causes using our state-of-the-art equipment, testing lab and engineering experience.

### All Reported Incident Cause Breakdown 2019 Year-To-Date, All States

As the data shows above, welds and corrosion are the leading causes of pipeline failures. Welds hold the many sections of pipelines together. This is a common process used to fuse sections together using heat and a filler material, and is common in piping to securely connect different lengths together. But it is a craft as much as it is a science. An insufficient weld is all that is needed to cause a dangerous and premature failure. When poorly heated, a weld may not penetrate enough to securely connect two parts, but when heated too much, it may compromise the chemistry and the performance of the base material.

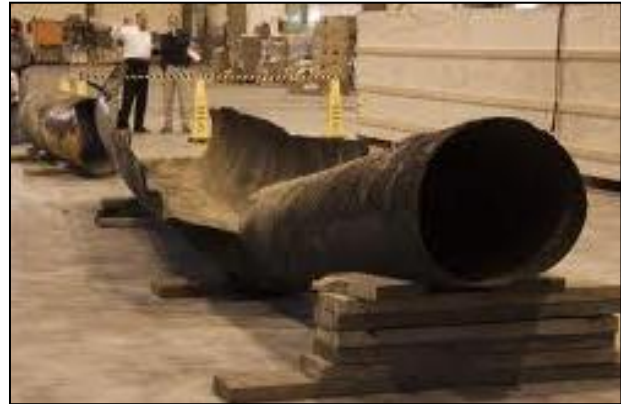
The San Bruno pipeline disaster occurred when a natural gas pipeline owned by PG&E exploded into flames in a neighborhood just west of the San Francisco Airport. The failed section of the pipeline is shown below. The devastation was immense—almost 50 homes were destroyed, and nine fatalities resulted. The image on the first page of this brochure reveals only a portion of this damage. BEAR inspected the failure and identified its cause as defective welds in the pipeline. The intensive pressure in the line, and the increasing demand for energy from San Bruno's expanding user base lead to this failure.
